APOLLO 16 MISSION

ANOMALY REPORT NO. 6

REACTION CONTROL SYSTEM
HELIUM PRESSURE REGULATOR FILTER FAILURE

MANNED SPACECRAFT CENTER
HOUSTON, TEXAS
DECEMBER 1972

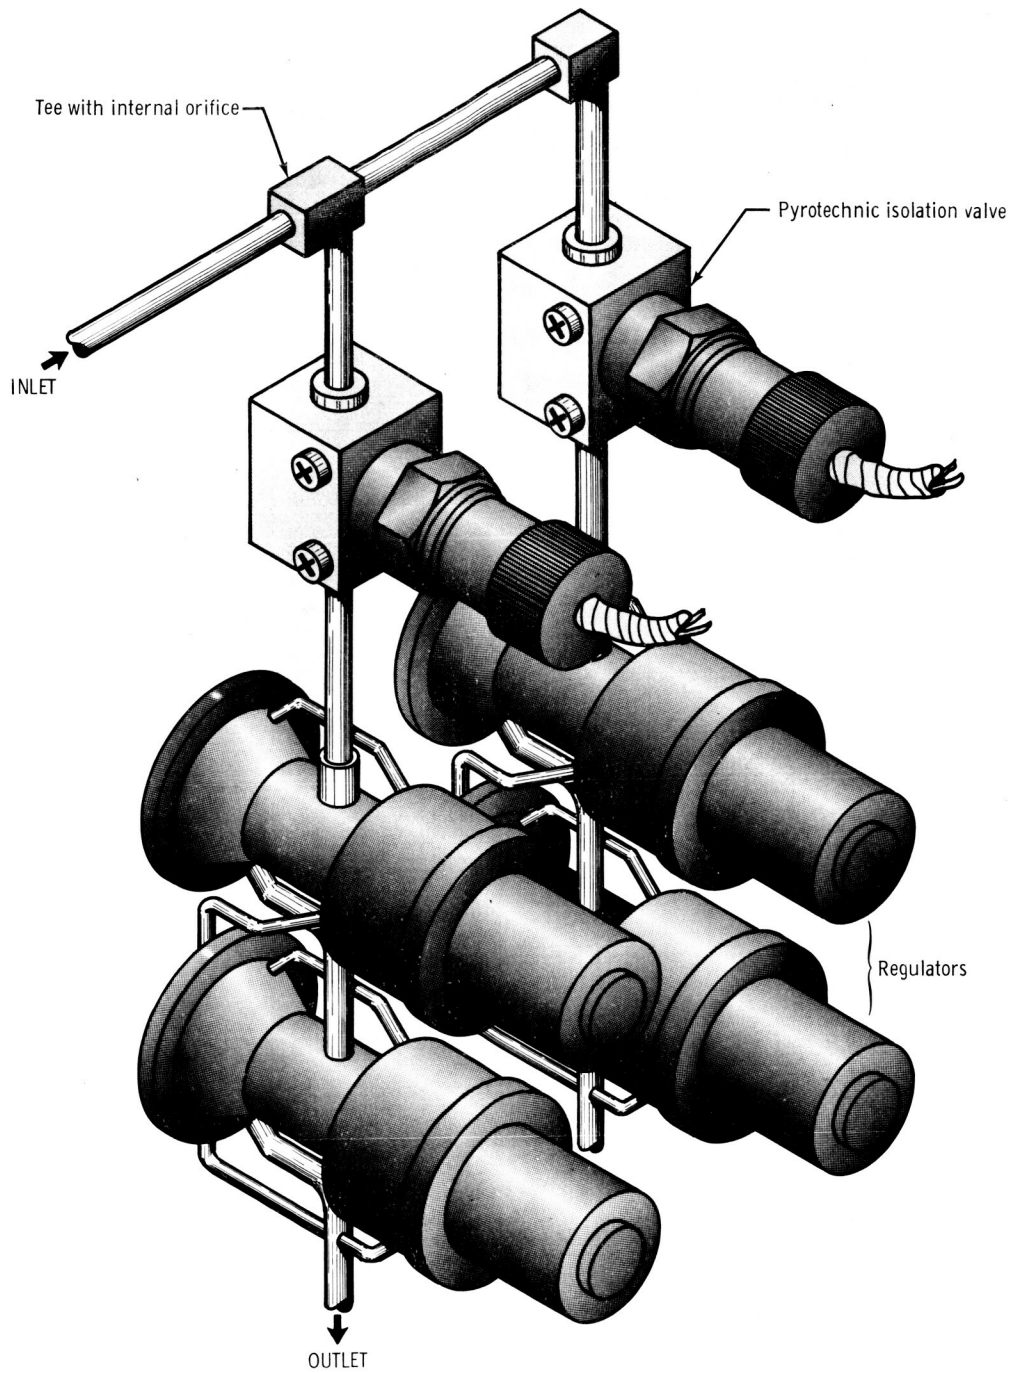
Figure 2. - Helium pressurization system configuration.

The helium is stored in the two tanks at 4150 psi. Each tank has a pressure reduction system (figs. 1 and 2) consisting of a 0.055-inch flow-limiting orifice feeding two pairs of series redundant regulators through pyrotechnically actuated isolation valves. The pyrotechnic valves each contain a 40-micron outlet filter to trap any debris generated during activation. The regulators are provided with 25-micron inlet filters.
